# Geotechnical-structural engineering for the preservation of Ninfeo Ponari in Roman Casinum

**ABSTRACT:** The Ninfeo Ponari is the unheated part of a domus built around the first century BC in the Roman city of Casinum on the lower slope of the Monte Cassino. Within a bigger archaeological complex present in this area the *nymphaeum* witnesses the historical-cultural relevance of this territory during the Roman age. Thus recovery, preservation and opening to public are considered a priority by local and national institutions. The structural integrity is threatened by the weight of debris fallen along the slope, that have totally overlaid the building. Different competences are involved to detect the composition and mechanical properties of the structural elements, monitor the geometrical-structural layout, investigate the subsoil conditions. A three-dimensional Finite Elements Model has been implemented, it serves to assess the present stability conditions and future recovery actions through the simulation of the soil-structure interaction. The analysis has required reconstructing the monument history through the interpretation of artifacts combined with the knowledge brought by

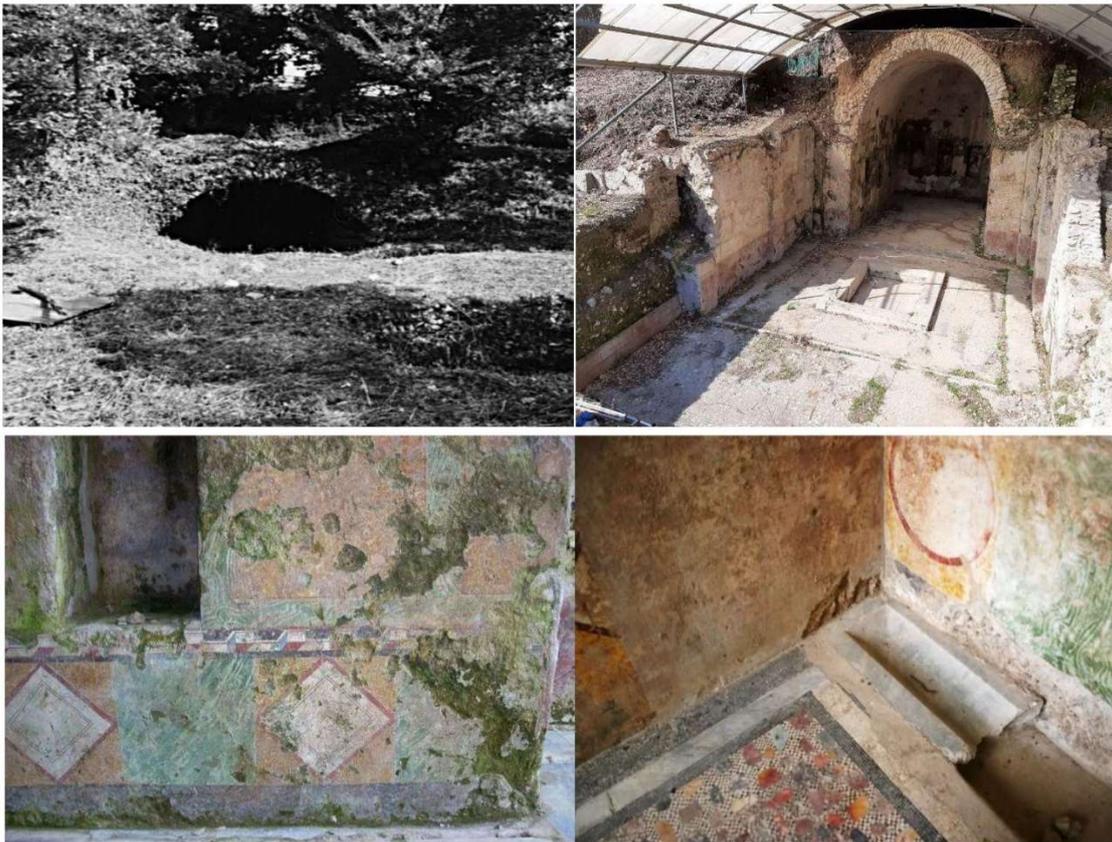
Figure 3. Picture of the Ninfeo Ponari before (a) and after excavation (b), example of painted wall with musk and vegetation (c) and of pavement (d).

Due to its similarity with other examples and the presence of shells and wall decorations, the building was classified as a nymphaeum, given its cave structure. It has been reasonably assumed that the nymphaeum, intended to host water games, was part of a luxurious private residence owned by one of the most important families of the ancient Casinum, the gens Ummidia. (Betori et al. 2009). Until the end of last century, the domus was left abandoned, being almost filled with earth and rubbles (Fig.3.a). A first excavation, accomplished between 1998 and 2001 (Betori et al. 2009), brought the structure to light and revealed a rich colored decoration (Fig.3.b). The presence of debris around the walls and on the vault has determined for long time, and still determines, a meaningful overload on the masonry structures. Neither the inner excavation can be assumed to relief this state. In fact, the contact of the walls with the ground continuously determines infiltration of groundwater that leaks through the masonry and contributes to deteriorate the status of mortar joints and plaster forming musk and vegetation that cover the wall surfaces (Fig.3.c).

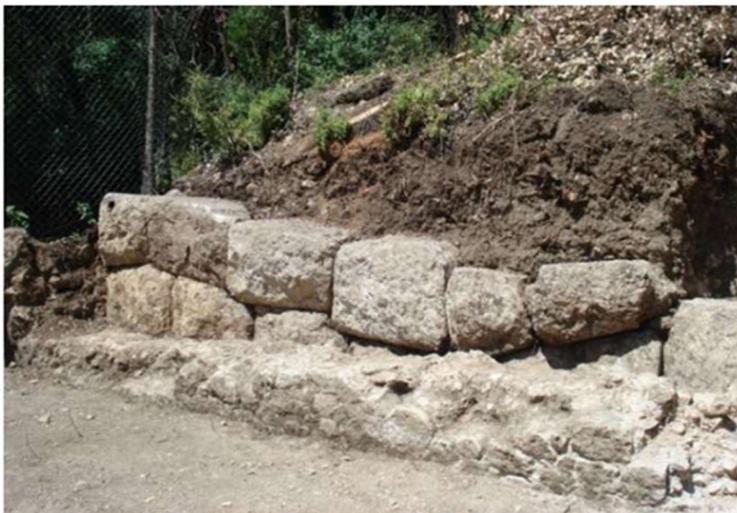
Figure 6. Picture of the polygonal wall (c). The geometrical model implemented in the analysis evolves as described in Figure 7 (from b to e).

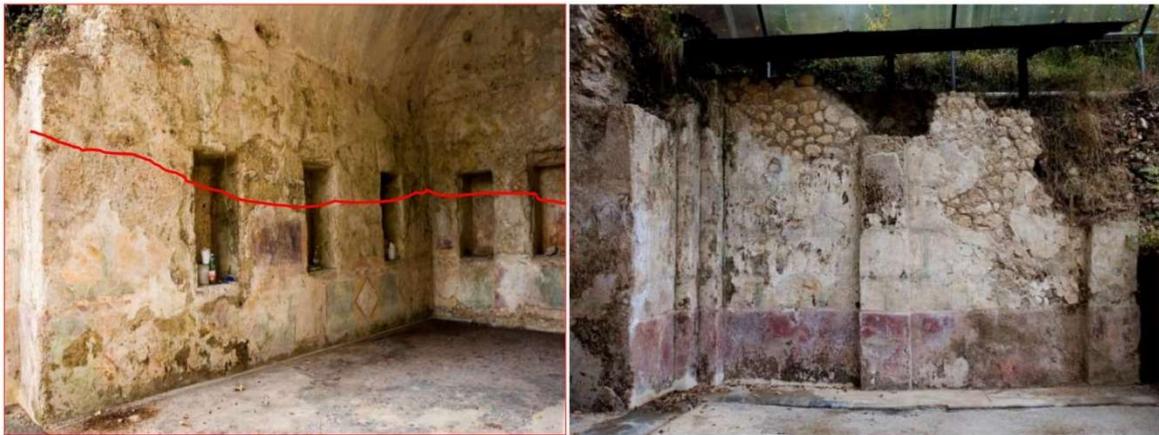
Figure 12. Cracks along the vaulted room (a) and rotated walls in the outer space (b) of the nymphaeum.

The computed movements become higher when the analysis is performed considering the heavier unit weight that may occur after heavy rain. This phenomenon, highlighted by the horizontal alignment of plastic points at middle height of the walls and at the vault abutment. is consistent with the direct observation of damage on the *nymphaeum* (Fig.12.a). Another important effect shown by the plastic point distribution is the weakness of the walls in the open atrium (Fig.12.b).

At present, these walls are in a very critical state, being subjected to a significant inward tilting that have alarmed the operators encouraging to undertake local stability intervention in the last years. In conclusion, the structural response is dominated throughout the *nymphaeum* life by the interaction with the outer soil, that represents the main cause of concern, but severity increases with the weight of up-hill soil as confirmed by the increased number and extension of plastic and tension cut-offs points observed in the numerical calculation.
