Dynamic and quasi-static strength of additively repaired aluminum ^{EP}

J. Appl. Phys. 136, 095902 (2024)

Additive manufacturing has the potential to repair high value components, saving significant time and resources; however, the level of reliability and performance of additive repairs is still relatively unknown. In this work, the structure–property and performance of laser wire additive manufacturing repairs in 1100 aluminum are investigated. Two types of intentional damage are inflicted on the samples and subsequently repaired with pulsed laser deposition additive manufacturing. Quasi-static (10^{-3} s^{-1}) and high strain-rate (10^{-3} s^{-1}) mechanical testing is carried out with *in situ* diagnostics and post-mortem imaging. The results show that while the quasi-static strength and ductility of samples with a repaired region are lower than a pristine sample, the dynamic strength under shock loading is comparable. This work highlights both the potential utility of additive manufacturing for repair purposes, the significant risk of compromised performance of additive parts under specific conditions, and the need to test at varying strain rates to fully characterize materi

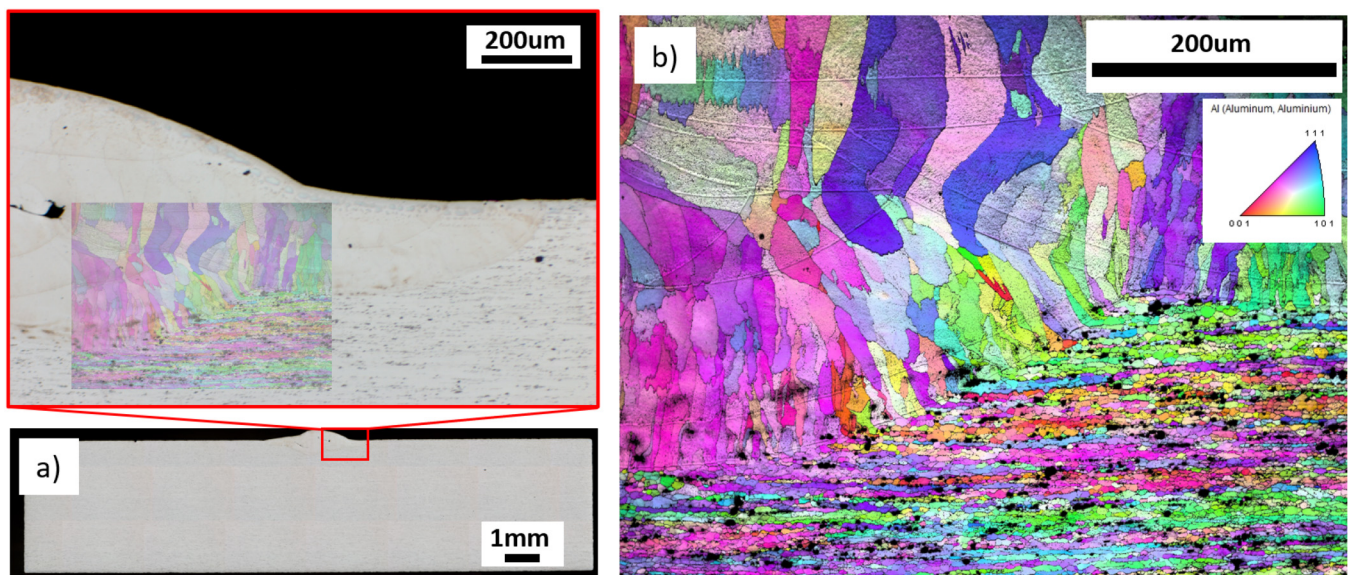
FIG. 2. Repaired scratch puck sample showing (a) optical micrograph stitch with the zoom region, which highlights the pristine/original material microstructure at the bottom and AM weld repair at the top. The weld was built proud of the top surface of the sample, and a single large pore is visible in the bulk of the repair region. The transparent overlay corresponds to the electron backscatter diffraction map in (b) which clearly shows the original, textured microstructure of the rolled plate from which the sample was cut, in contrast to the large columnar grains of the repair region. The AM weld melt pools can be made out due to the image quality grayscale that is shown along with the inverse pole figure colormap. The build direction is toward the top of the page.

This led to significant contamination during the repair and was a probable source of porosity. The geometry of the porosity in Fig. 2(a) and the callout implies that some organics or chemicals were volatilized during the repair. Further sources of contamination that should be accounted for in future work include oxidation of the filler wire, which due to its large surface area to volume ratio may have introduced a significant amount of oxides into the repair, and oxidation of the aluminum sample surface itself, which was possible despite the use of argon shielding gas.

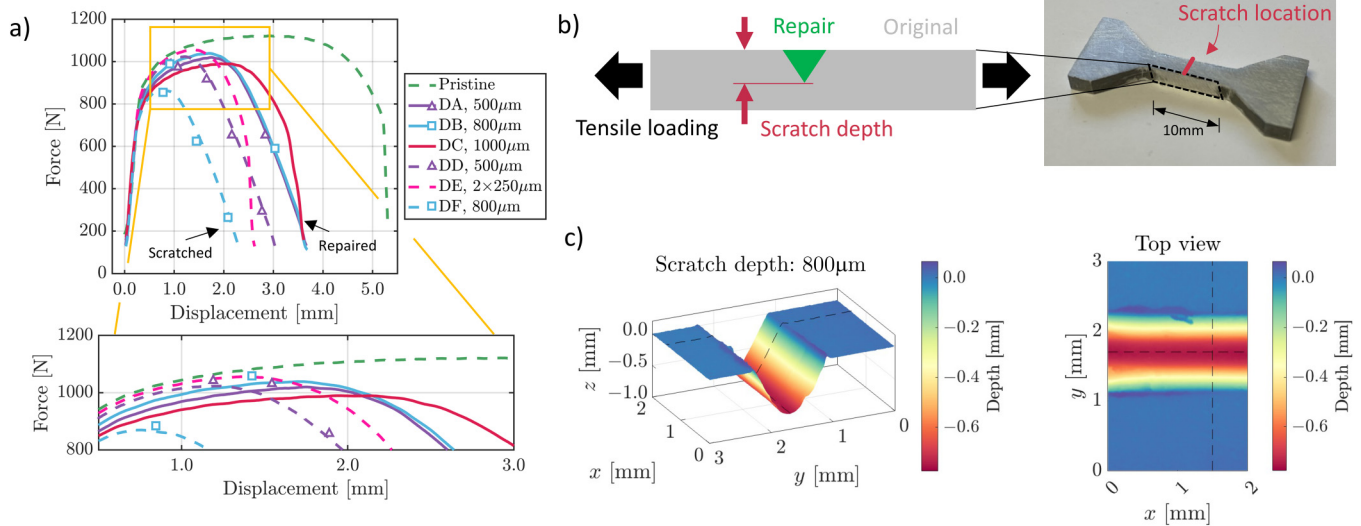
FIG. 3. Quasi-static AM repair testing results: (a) tensile test force–displacement curves showing the pristine sample and three different scratch/repair depths, (b) tensile dogbone sample photo and repair geometry and location illustration, and (c) laser confocal microscopy profile of a scratched sample in isometric and top-down view showing the scratch geometry before repair. Sample DE had two scratches of depth 250 μm placed on either side of the sample to determine the influence of the scratch asymmetry with no repair: the effective reduction in cross-sectional area is the same as DD but the scratches are symmetric across the sample.

The 1100 aluminum dogbone samples, pristine, scratch repaired (dogbone DA with 500 μm deep scratch repair, dogbone DB with 800 μm , and dogbone DC with 1000 μm deep scratch repair), and scratched with no repair (dogbone DD with 500 μm deep scratch, dogbone DE with two 250 μm scratches, one on each side, and dogbone DF with 800 μm deep scratch) were tested at quasi-static strain-rate under uniaxial force loading to determine the tensile strength and failure mode under uniaxial low strain-rate conditions. A total of seven dogbone specimens were tested, and all the force–displacement results are presented in Fig. 3. The quasi-static tests were carried out at 10^{-3} s^{-1} using an MTS hydraulic load frame. A photo of an untested dogbone sample is shown in Fig. 3(b), and the sample was 31.75 mm long with gauge section length 12.7 mm and thickness 3.18 mm. The dogbones were scratched in the middle of the gauge section on one side as shown in Figs. 3(b) and 3(c). The scratch geometry is shown in Fig. 3(c) for an example case of a 800 μm scratch depth. Laser confocal microscopy was used to capture the surface geometry and texture of the sample before the repair was made. The color and

three-dimensional rendering of the sample surface demonstrates the consistency and uniformity of the scratch intentional damage site. After the repair, the AM material was filed back and the sample surface was sanded smooth. The repairs were not visible to the naked eye, but the results shown in Fig. 3(a) demonstrate that the tensile strength of the samples was compromised significantly compared to the pristine case. The results in Fig. 3(a) are left in terms of force and displacement as measured directly during testing. Since the sample cross section is not uniform (i.e., the weld is only on one side), the stress is not uniaxial. For the pristine case, the uniaxial conditions do apply, so the stress and strain are reported in Sec. III A for that case. In future work, it may be possible to develop a repair specimen geometry that has a uniform cross section at each point along the gauge length (to achieve the uniaxial condition in a repaired sample) by cutting the sample completely and including a fully repair material region, but that is beyond the scope of this work due to limitations in the AM system.

The quasi-static yield stress and ductility of the repaired samples were significantly lower than the pristine case. The pristine sample had an ultimate tensile strength of 137 MPa and a max strain of 0.35. While the ultimate strength could not be accurately determined for the repaired samples due to the non-uniform stress distribution, examining Fig. 3(a) shows that both the yield and strain to failure are significantly lower for all three repair depths. In Fig. 3(a), the repaired samples are shown in solid lines and the samples with no repair—including the pristine sample—are shown in a dashed line. The markers indicate which samples are comparable between the repair and un-repaired cases, i.e., the solid line

with a triangular marker is sample DA with a repaired $500\ \mu\text{m}$ scratch, and the dashed line with the triangular marker is sample DD with the un-repaired $500\ \mu\text{m}$ scratch. The elastic response of all seven samples is qualitatively the same; however, there are differences in yield force where the material transitions to plastic deformation. Specifically, there is a decrease in the yield force as a function of increasing defect size, with the $1000\ \mu\text{m}$ deep scratch repair approximately $100\ \text{N}$ below the pristine case, and the un-repaired $1000\ \mu\text{m}$ more than $200\ \text{N}$ lower. The repaired samples DA and DB can be directly compared to their un-repaired counterparts DD and DF. The comparison shows that while the repair did not fully recover the strength of the pristine sample, it did improve the strength relative to the un-repaired cases. Interestingly, sample DB showed a slightly higher ultimate force than case DA even though the repair region was larger. It is possible that the repair has a higher ultimate strength than the original material but the repair interface likely has a lower strength than both materials. Since case DC had a very large repair interface, it failed quickly. It is possible that case DB benefited from the higher strength of the repair material relative to case DA without being compromised by the repair interface to the same extent as case DC. Further testing would be necessary to confirm this quantitatively.

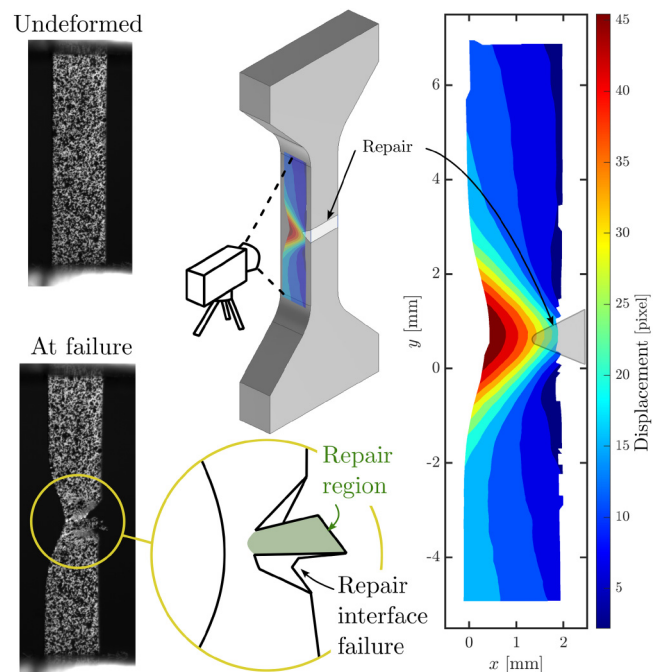
FIG. 4. Digital image correlation analysis of scratch repaired 1100 aluminum sample dogbone DA ($500\ \mu\text{m}$ scratch depth with repair) under quasi-static loading. The colormap shows the displacement from the original, unloaded position of each location on the sample. The displacement is highly asymmetric, indicating that the necking behavior is non-uniform: the original material deforms significantly, while the repair region does not deform.

Two frames from the DIC recording series are shown on the left side of Fig. 4: the undeformed sample before testing, and the sample just at failure. The speckled paint is visible and in the lower photo of the sample at failure, the asymmetry can be observed. A callout illustration explains the failure mode: the repair region appeared to separate from the base material at the interface. The colorful DIC image contour map in Fig. 4 shows the displacement of each pixel on the sample just at failure, and with an illustration of the triangular repair region overlaid in gray. The colormap shows that the sample deformation is asymmetric: the material on the left side of the sample, the base material from the original 1100 plate which is “under” the repair, deformed substantially and showed characteristic necking similar to what was observed in the pristine case. The right side of the sample, however, showed very

little deformation. The color corresponds to the displacement in terms of pixels: the bright red region, which showed the most deformation is where the original material is. This result indicates that the repair was less ductile than the original material and failure initiated at the repair boundary.

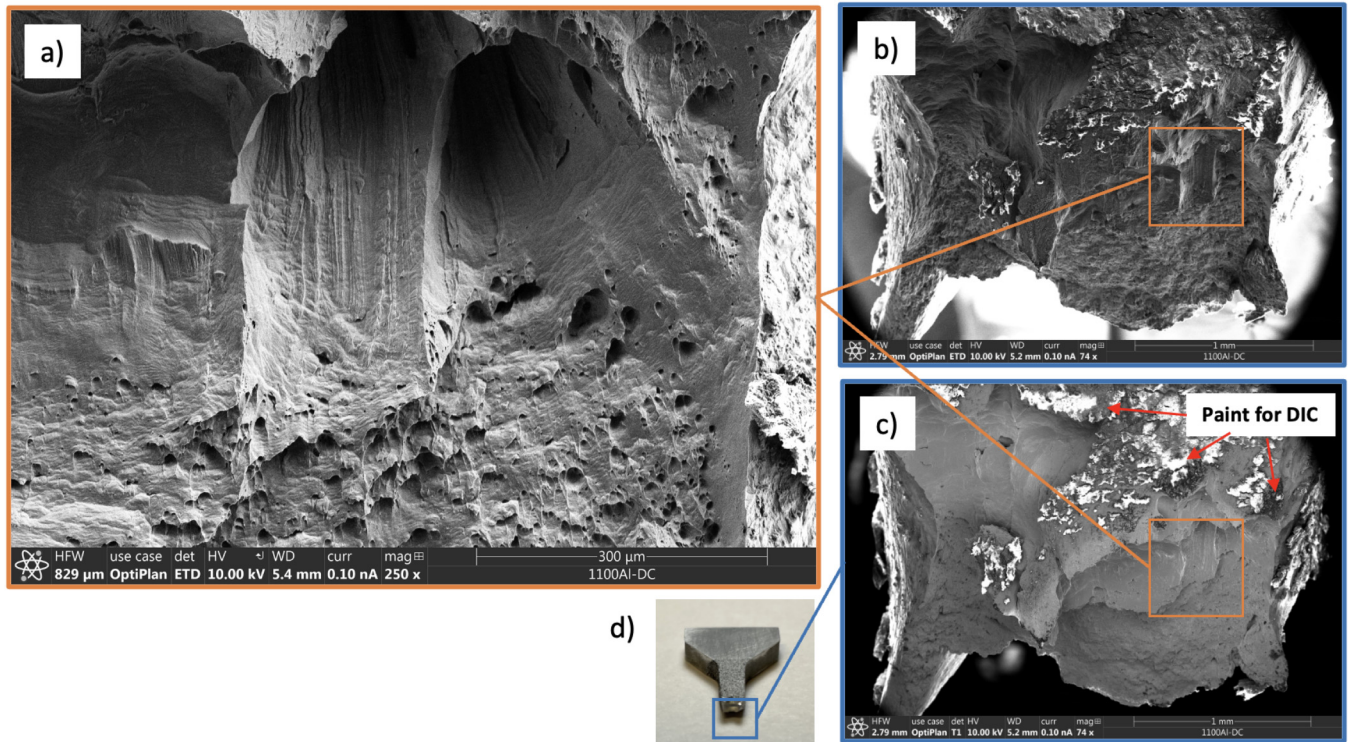
FIG. 5. Scanning electron microscopy of the fracture surface of the dogbone sample DC (1000 μm scratch depth with repair) after quasi-static loading. Detail view (a) shows the closeup of the key fracture surface where the repair region is roughly at the top half of the image and the original material is roughly at the bottom half: the original material shows evidence of highly ductile fracture, while the repair shows more brittle characteristics and large smoother regions. The intermediate zoom views in (b) and (c) show two angles, which both include the zoom view in (a) but also show the context within the entire sample, and the photo in (d) shows the reference location in the entire half of the original dogbone.

The post-mortem quasi-static dogbone samples were mounted in a SEM and imaged to determine the failure modes under low strain-rate loading. The SEM images are shown in Fig. 5 for dogbone sample DC. The SEM images show differences in the fracture morphology between the original material and the repair material. In Fig. 5(a), the original material is on the bottom half of the image, and the repair material is in the top half of the image. The pristine material, which is underneath the repair region during the AM process, shows characteristically ductile fracture traits such as dimpling. The repair region, however, appears to show a different failure mode. The large fracture surfaces at the top of Fig. 5(a) appear to correspond to the larger grains in the AM region. They also indicate a more brittle failure mode. The lower ductility of the AM repair region offers some explanation for the reduced strength of the repaired dogbones under quasi-static loading: the original material, with its considerable ductility, does not benefit from the

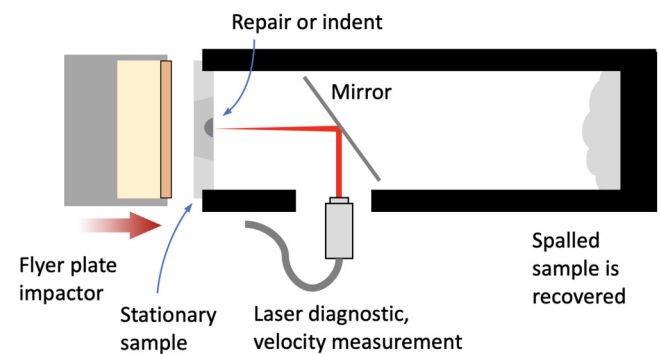
FIG. 6. Illustration of shock loading impact setup: incident projectile with copper flyer plate, stationary sample with repair, indent, or scratch location, laser velocimetry, and post-impact sample recovery setup with catch tank.

The shock impact testing was carried out on a 19 mm bore light-gas gun. Argon gas was pressurized inside of a wrap-around breech, and a dual o-ring projectile made of Lexan and fitted with a flyer plate was launched down the barrel. An illustration of the impact setup is shown in Fig. 6: the projectile with flyer plate (copper in this case) and its velocity direction, the stationary sample with repair or indent location, and laser velocimetry measurement position are all indicated. The back of the flyer plate was fitted with syntactic foam to support the flyer during launch. Projectile velocity immediately before impact was measured with a pair of laser light-gates spaced at a known distance. The sample was secured on the front face of a catch tank and aligned to the barrel axis. The sample was tapered to aid in recovery and fitted with an 1100 aluminum momentum ring such that edge releases were minimized in the spall region. The rear free-surface velocity was measured with up-shifted photon Doppler velocimetry (PDV)

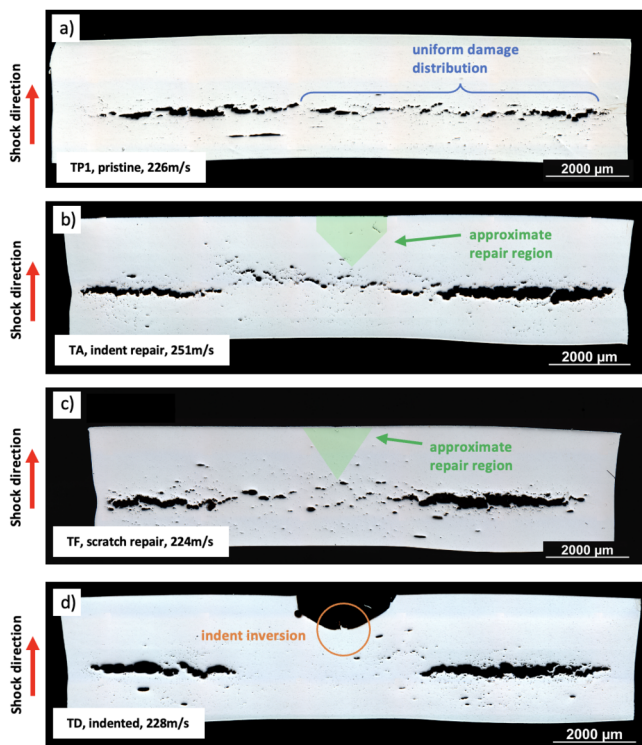
FIG. 8. Post-mortem metallography results for shock loaded spall samples: (a) pristine 1100 aluminum sample with benchmark uniform damage distribution for incipient spallation, (b) AM repaired conical indent with repair region illustrated showing some irregularities in damage distribution, (c) AM repaired scratched sample showing similar damage formation to indent case, and (d) unrepaired indent sample showing no damage formation under indent and inverted geometry at the base of the conical region.

The shock loading targets were recovered after impact and sectioned along their diameter. The sections were mounted in epoxy and ground with increasingly fine SiC paper, then polished with $1\mu\text{m}$ alpha alumina slurry and then $0.04\mu\text{m}$ colloidal silica. Optical images of the polished samples are shown in Fig. 8. Figure 8(a) shows the pristine sample, which serves as the performance benchmark. The incipient spall damage is formed approximately at the center of the sample and shows ductile void growth as expected. The additively repaired indented sample, TA, is shown in Fig. 8(b). The approximate region of the AM repair is highlighted. The spall damage distribution is observed to be similar in overall trend as compared to the pristine sample case, but slightly more irregular. The damage is seemingly concentrated in the first and last third of the sample width, and the center third (directly under the repair) is slightly less intense per unit area. The same trend is true for the AM repaired scratch case shown in Fig. 8(c): the damage distribution seems more bi-modal than in the pristine case; however, voids are still observed across the entire width. In the un-repaired indent case, Fig. 8(d), two new features appear: the damage is only present in the first and last third of the sample, and the indent geometry has changed significantly. The lack of damage

in the center third of the indented sample demonstrates a “shadow” effect that occurs when the shock transit time is different due to the change in the geometry—the rarefaction waves do not interact to create a region of high tension, and, therefore, no spall occurs immediately under the indent.

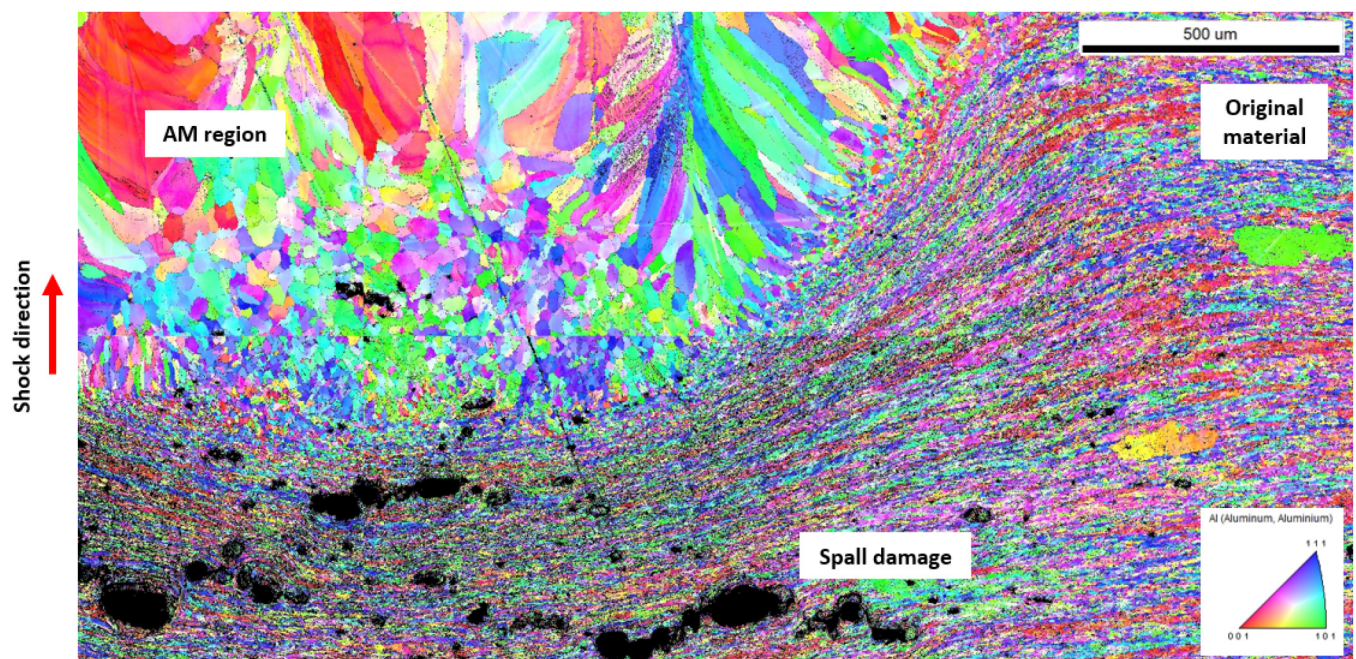
FIG. 10. Post-mortem electron backscatter diffraction image of sample TA, which was intentionally indented, repaired with wire-fed laser additive manufacturing, and then subjected to shock loading to form incipient spall damage at high strain-rate.

A large montage EBSD scan is shown in Fig. 10, sample TA, AM indent repair, after shock loading. The scan shows the original plate material with highly textured grains, as well as the parabolic-shaped deformation that occurred during the indentation damage

process. The AM region can be observed in the upper left region of the image with the large grains and some distinct and familiar evidence of rapid cooling, thermal gradients, and repeated heat cycling. The spall damage appears in the bottom half of the image, predominantly in the pristine material due to the design of the experiment—the sample and flyer thickness were chosen such that the spall plane occurred in the middle of the sample, but the repair does not extend to that depth. This image demonstrates that the repair region does not influence the damage nucleation or formation except for the presence of porosity. The heat affected zone and large grains are not relevant at the applied stress, and the spall damage still forms roughly where expected.
